SHAWNEE DAM

NDI I.D. NO: 832

**PHASE I INSPECTION REPORT
NATIONAL DAM INSPECTION PROGRAM**

SEPTEMBER 1978

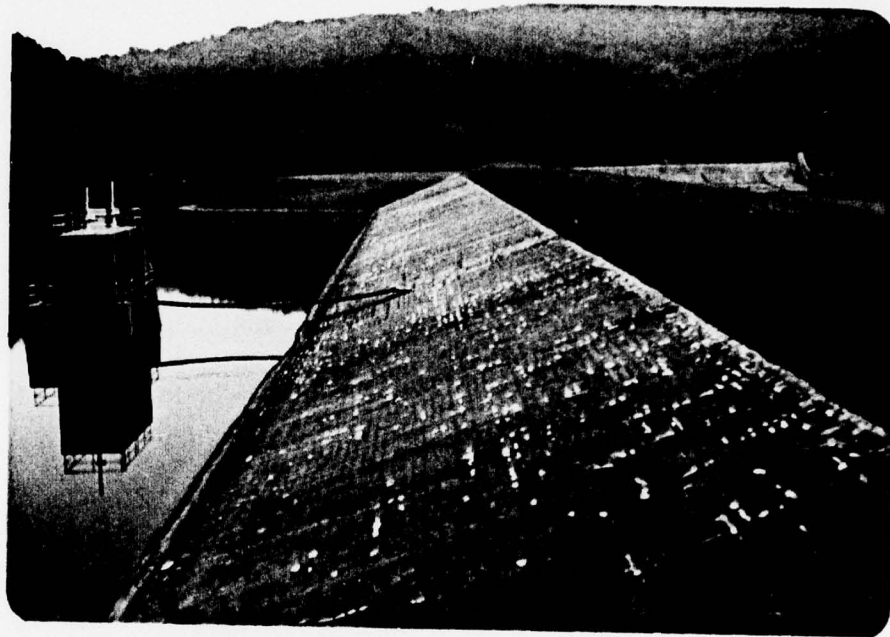
Upstream Face

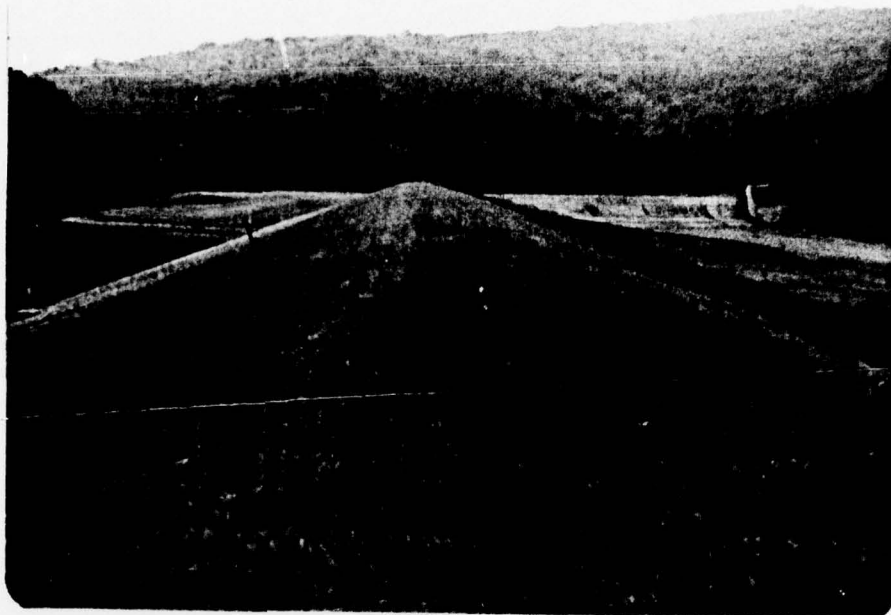
Photograph No. 1
Crest (looking northeast).

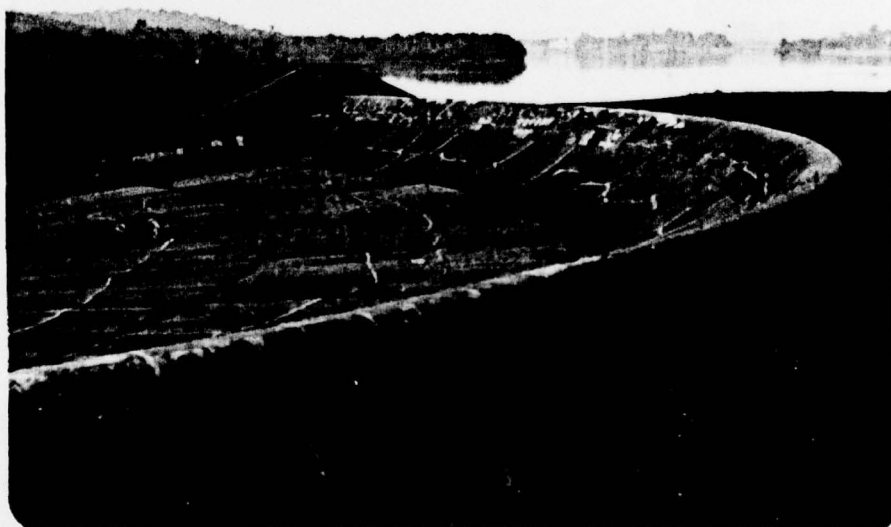
VISUAL EXAMINATION OF	OBSERVATIONS	REMARKS OR RECOMMENDATIONS
CONCRETE WEIR	Siphon spillway weirs are not visible. Emergency spillway weir is in good condition.	
APPROACH CHANNEL	Emergency spillway approach channel is free of obstructions.	
DISCHARGE CHANNEL	Emergency spillway discharge channel is in good condition; no apparent obstructions.	
BRIDGE AND PIERS	None

Photograph No. 2
Spillway crest.

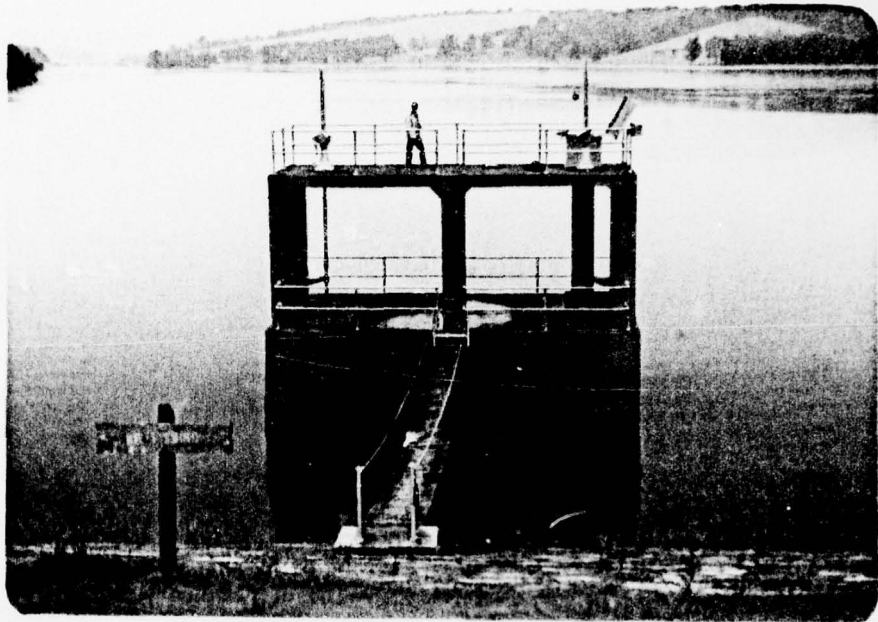
Photograph No. 3
Siphon spillway intake tower.

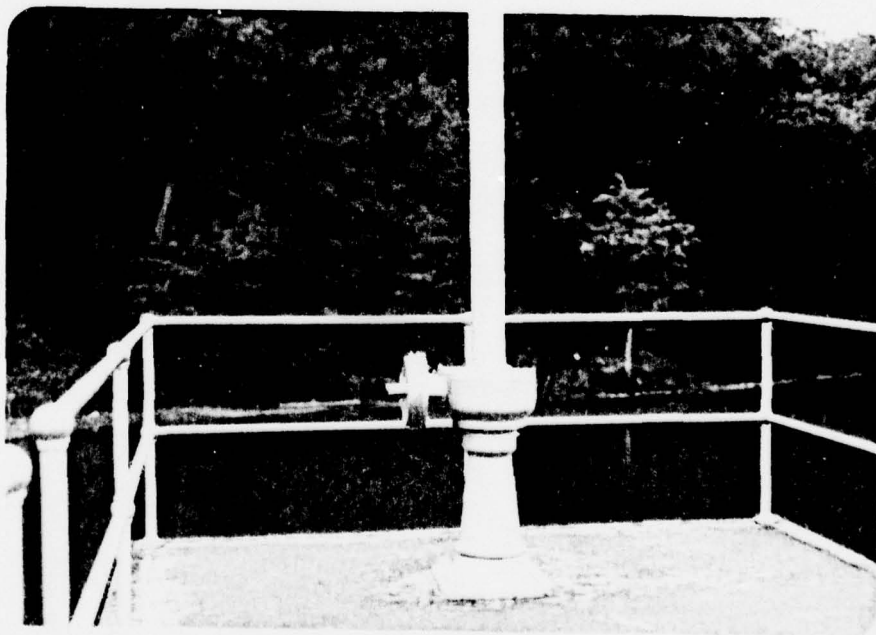
The operation of the outlet sluice gates was observed and found to be functional.

Photograph No. 4
Outlet gate hoist.

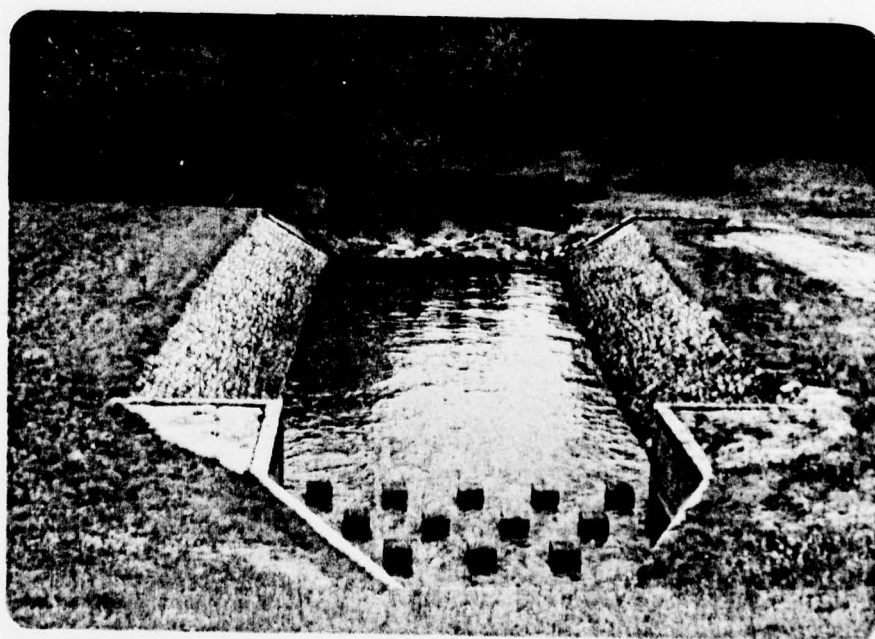
Photograph No. 6

Outlet conduit discharge channel.

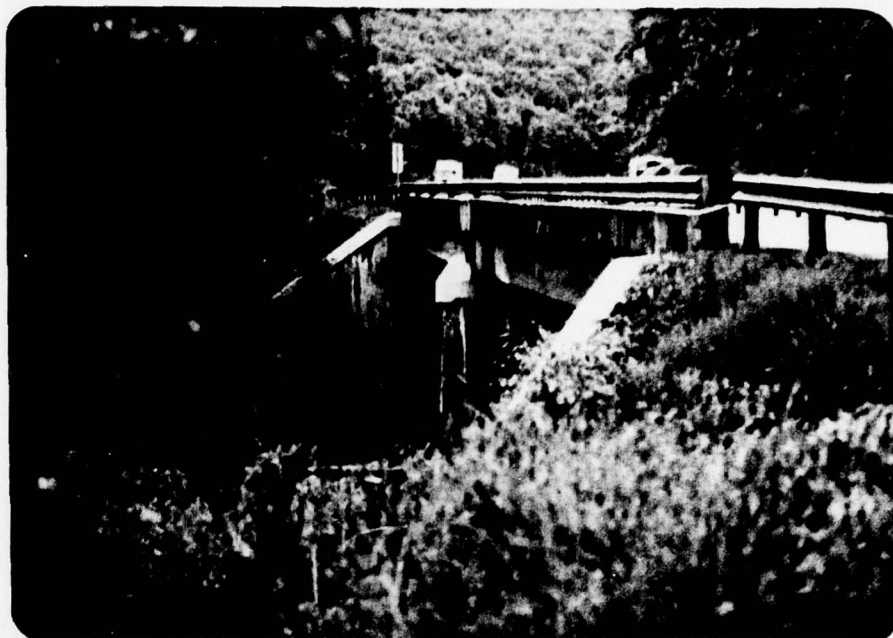
Photograph No. 7

Bridge on Pennsylvania Turnpike over
Shawnee Branch (one mile downstream).

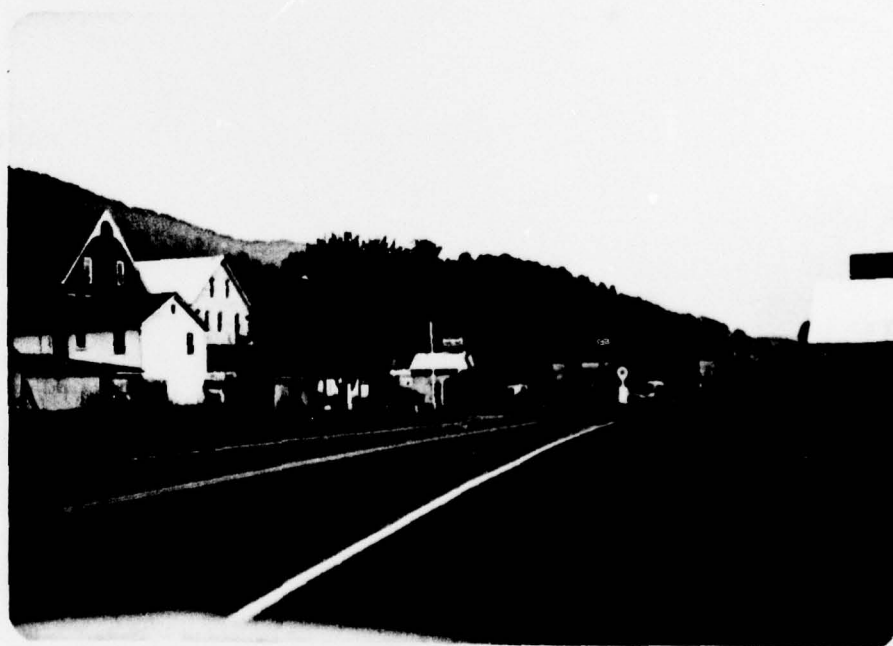
Photograph No. 8

Town of Manns Choice (two miles downstream
along Raystown Branch of the Juniata River).
